# Manhole Inspection Summary

Manhole # S29SS\_011MH

Insp Date: **8/5/08 12:45 PM**

**Location** Address: **2800 FALLS RD**

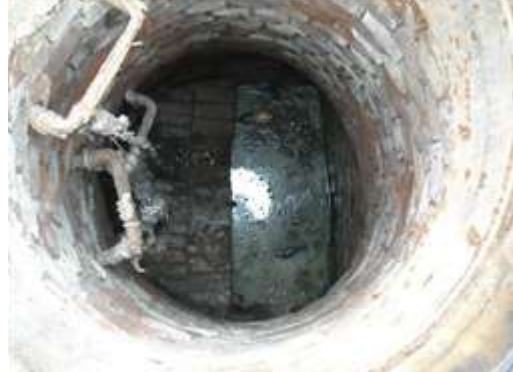
Top View

Corroded steps. Evidence of surcharge - Bench debris. Channel debris.

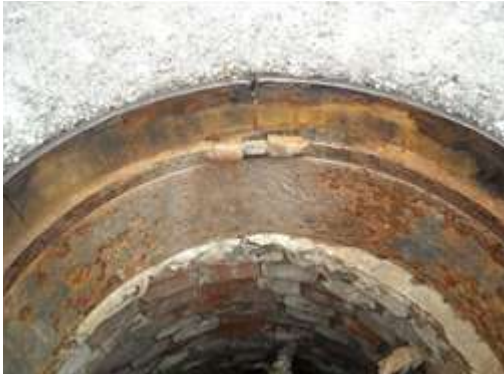
Metal Frame Adjustment

Causes the cover to be stuck.

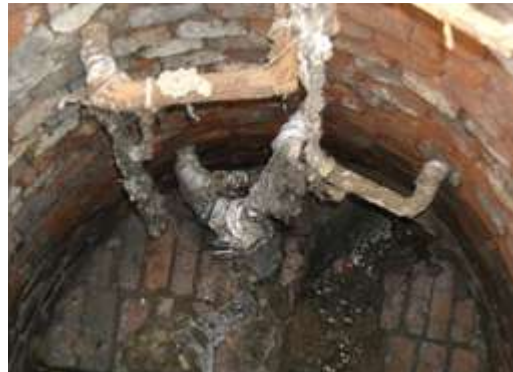
Defect

Barrel infiltration.

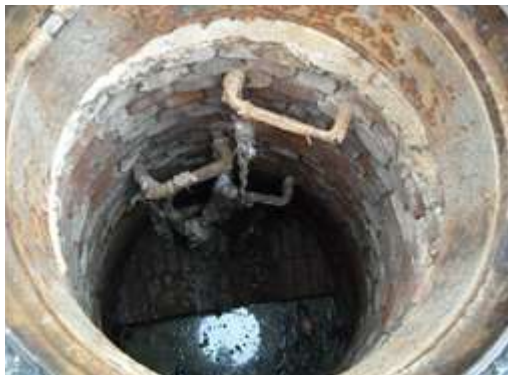
### Defect

Frame leaks. Adjustment and Corbel deterioration and infiltration. Barrel infiltration.

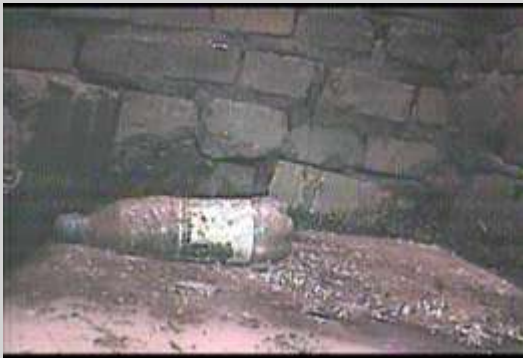
### 18 in. Circular Gravity Sewer Pipe Out @ 12 O'Clock

Deposits: ☐ None ☒ **Mud** ☐ Sludge ☒ **Debris** ☒ **Grease**

Silt Depth: **18** (in.) Deposits Extent: **Heavy**

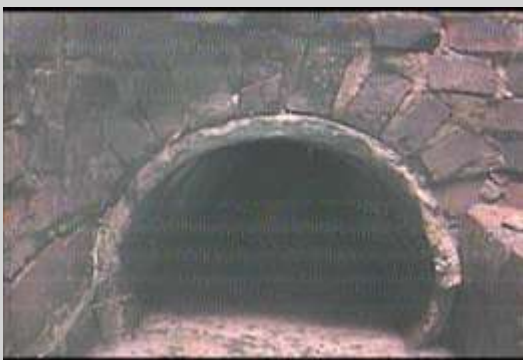
### 18 in. Circular Gravity Sewer Pipe In @ 6 O'Clock

Deposits: ☐ None ☒ **Mud** ☐ Sludge ☒ **Debris** ☒ **Grease**

Silt Depth: **5** (in.) Deposits Extent: **Medium**

Infiltration: **Evidence** Pipe Seal Cond: **Cracked**

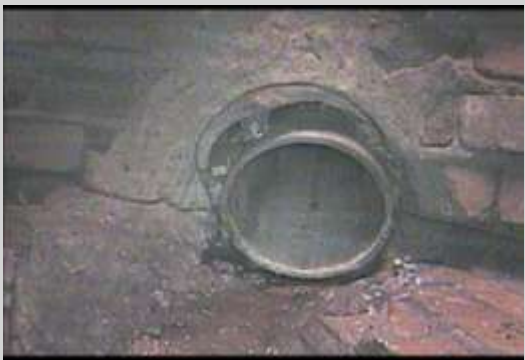
6 in. Circular Gravity Sewer  
Pipe In @ 10 O'Clock

Infiltration: **Weeper** Pipe Seal Cond: **Cracked**
